Engineering a 28% void queen-size brick strong enough for setting equipment

THE PROBLEM — Maintain structural integrity while increasing void

**THE SOLUTION –
A Steele L Die and V-2 Oil Pump**

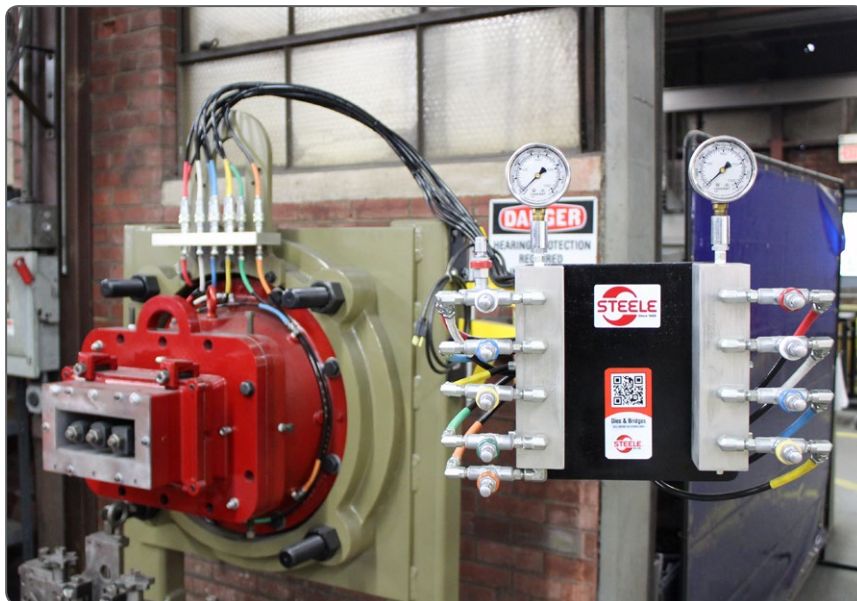
A remote die oil manifold articulating arm improved die lubrication and operator safety

Our engineers also provided a remote die oil manifold articulating arm, to maintain a safe distance between the operator and the extrusion area.
